Seattle Landslide Study Seattle Public Utilities Seattle, Washington

## IDEALIZED GEOLOGIC CONDITIONS TYPICAL SEATTLE HILLSIDE

SHANNON & WILSON, INC. Geotechnical and Environmental Consultants

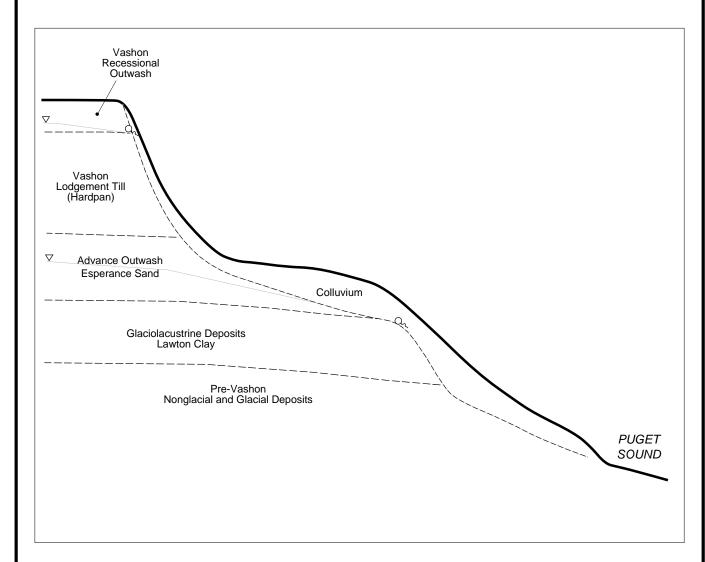
FIG. 1-1

The thicknesses and elevations of these geologic units vary from place to place, and one or more units could be missing due to previous erosion.
